Ocean Paradise Condominium Association, Inc.  
Cocoa Beach, Florida

At the direction of the Board that recognizes the need for proper reserve planning, we have conducted a *Structural Integrity Reserve Study* of Ocean Paradise Condominium Association, Inc. in Cocoa Beach, Florida and submit our findings in this report. The effective date of this study is the date of our visual, noninvasive inspection, September 20, 2023.

**Reference:** 222895

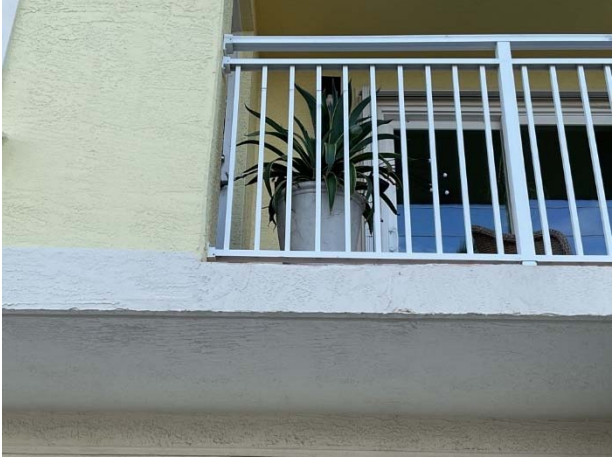
**Condition:** Good to fair overall with spalled concrete and water stains evident. The topsides of the balconies were inaccessible at the time of our inspection. Management did not report a history of repairs. We note the following:

- The coatings are reported in good to fair condition
- Isolated concrete coating deterioration is evident
- Isolated concrete edge spalls are evident

**Edge spalls**

**Useful Life:** Capital repairs including a close-up visual inspection, patching of delaminated concrete, routing and filling of cracked concrete, and waterproof coating applications every 8- to 12-years.

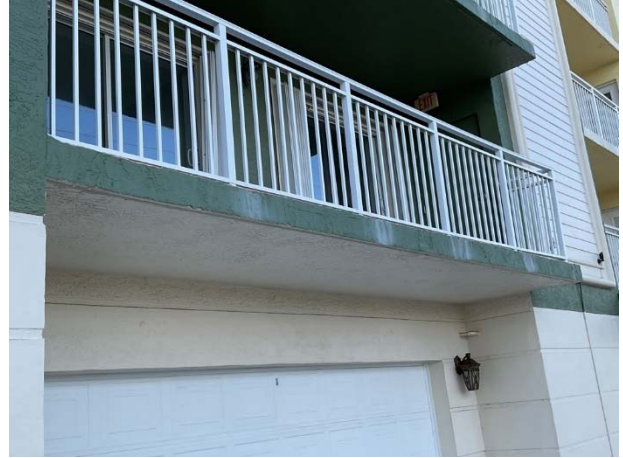
**Edge spalls and efflorescence**

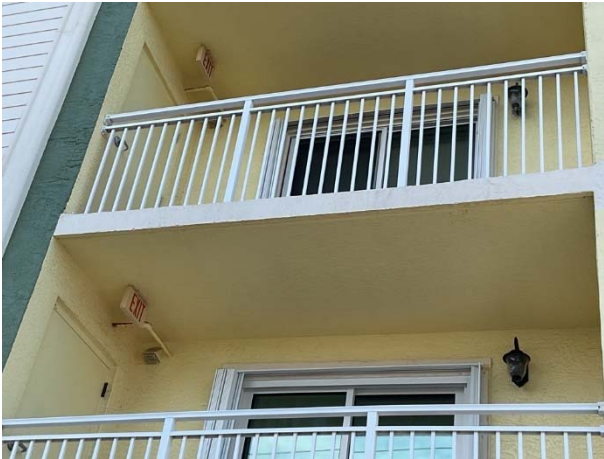
**Balcony underside**

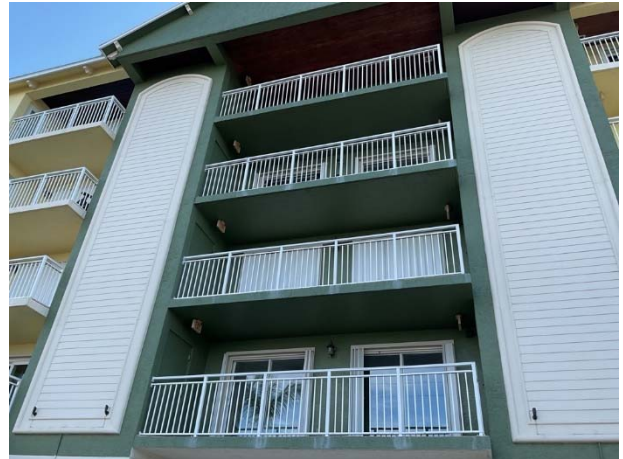
**Balconies overview**

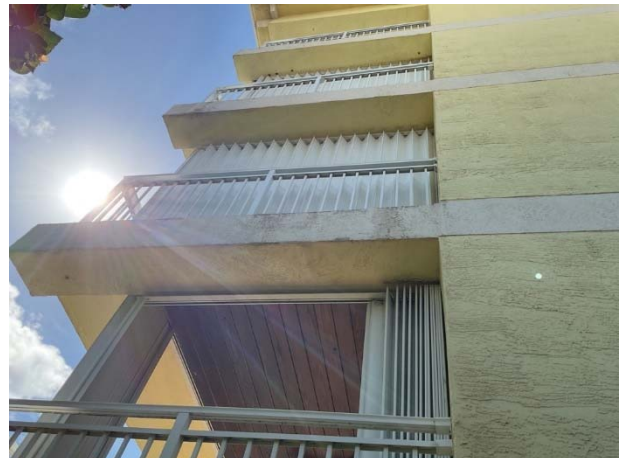
**Edge spalls and stucco deterioration**

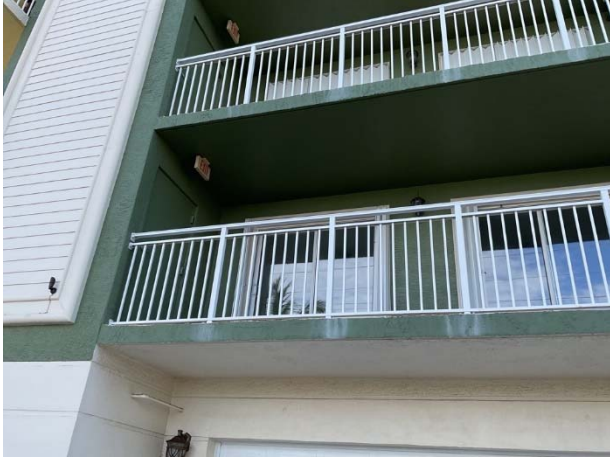
**Condition:** Good to fair overall with loose connections evident.

**Aluminum railings**

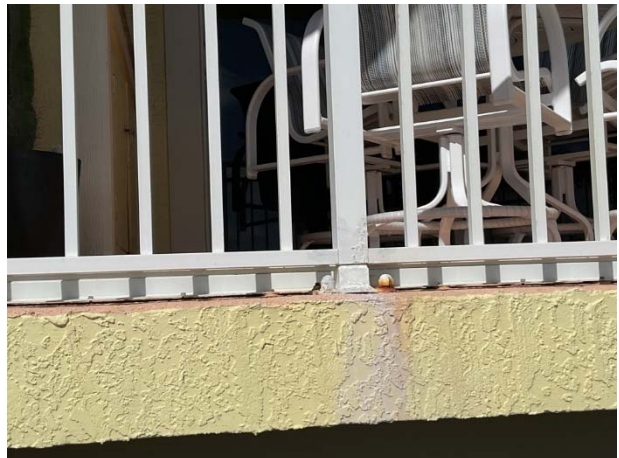
**Rust at concrete connection**

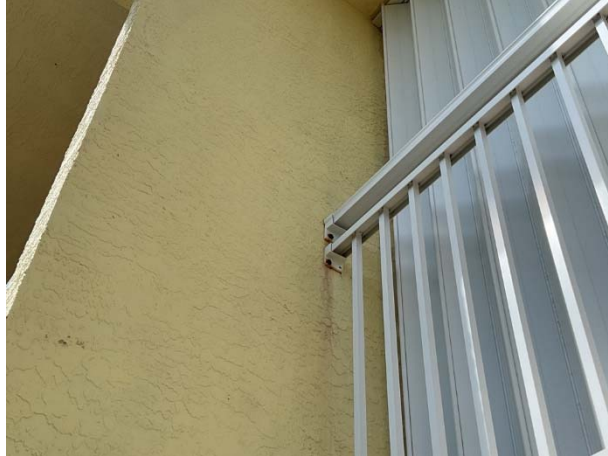
**Rust at stucco connection**

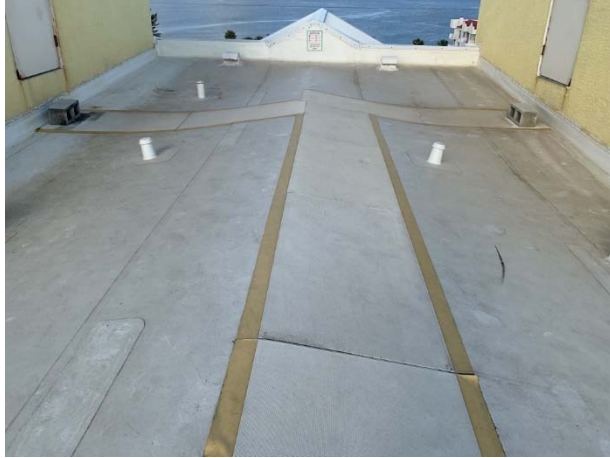
**Condition:** Good to fair overall with periodic bulges in the membrane and patches evident. Management does not report history of leaks. We note the following:

- Minor previous membrane repairs are evident
- Isolated sealant failure is evident
- Isolated blocked roof drains are evident
- Limited evidence of standing water

**Thermoplastic roof overview**

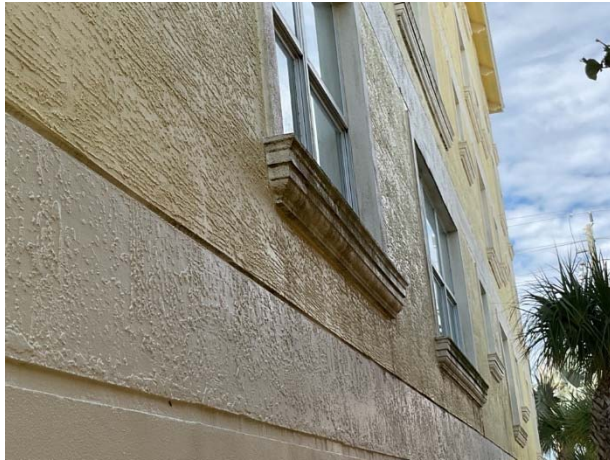
**Condition:** Good to fair overall with isolated damage, previous repairs, finish stains and rust stains (lath set too close to surface) evident.

**Finish deterioration**

**Useful Life:** We recommend inspections, repairs and paint finish applications every five- to seven-years.

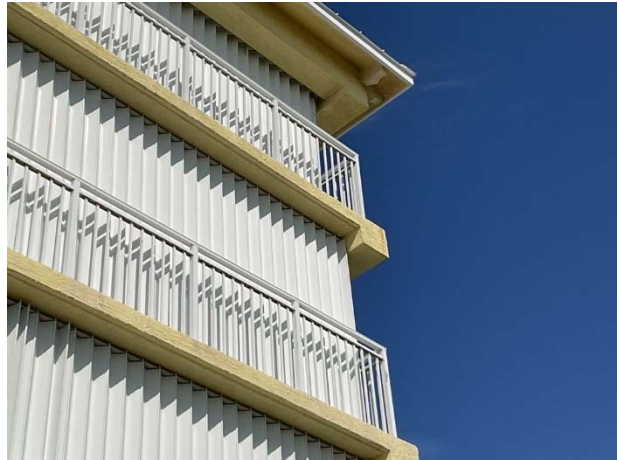
**Rust**

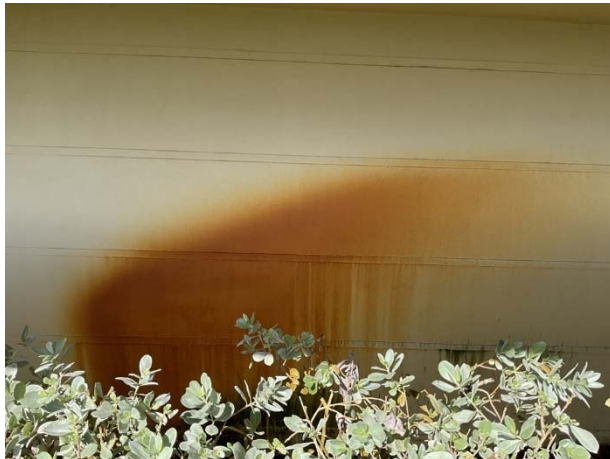
**Stains**

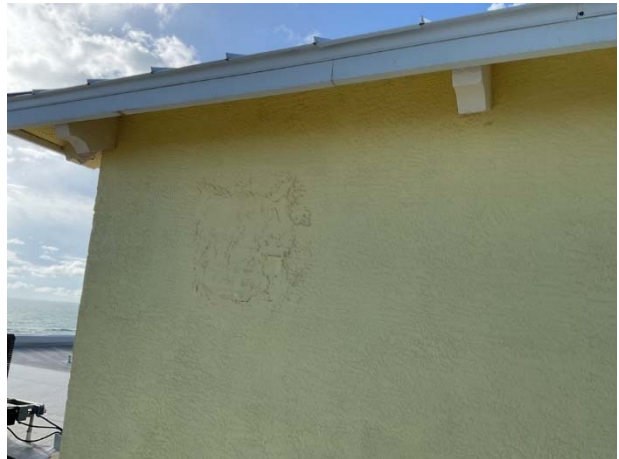
**Stucco damage at the north elevator room**

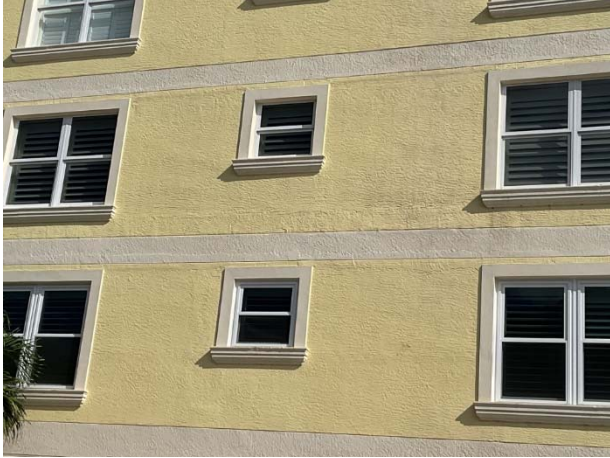
**Stucco damage**

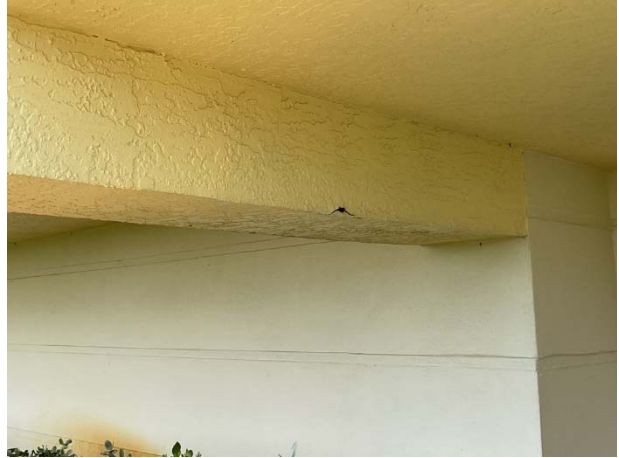
**Stucco damage**

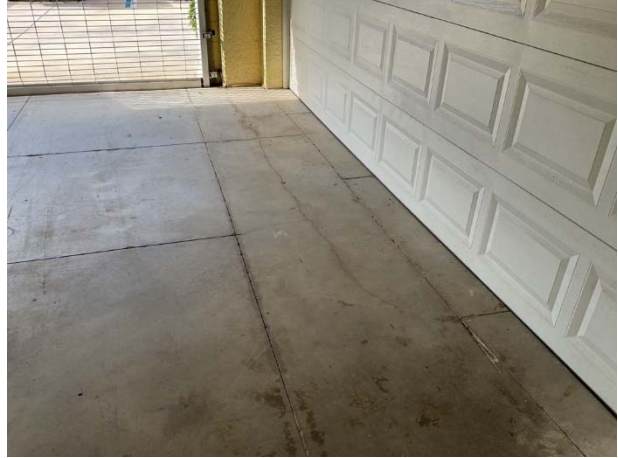
**Condition:** Good to fair overall with cracks evident.

**Concrete cracks**

**Useful Life:** Up to 90 years although interim deterioration of sections is common. We show partial replacements every five years.

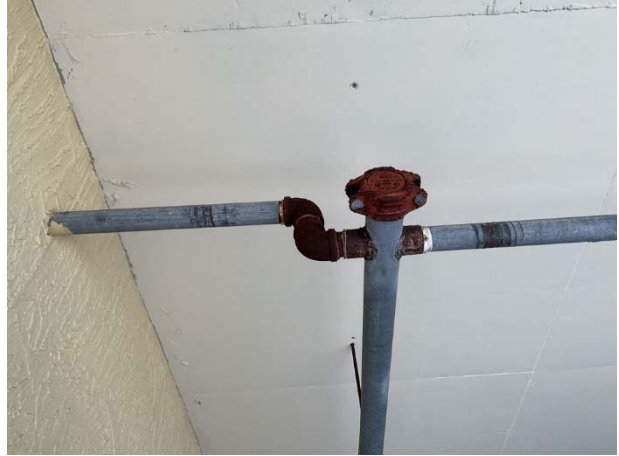
**Condition:** Fair overall with pipe rust and sprinkler head rust evident.

**Rust at pipes**

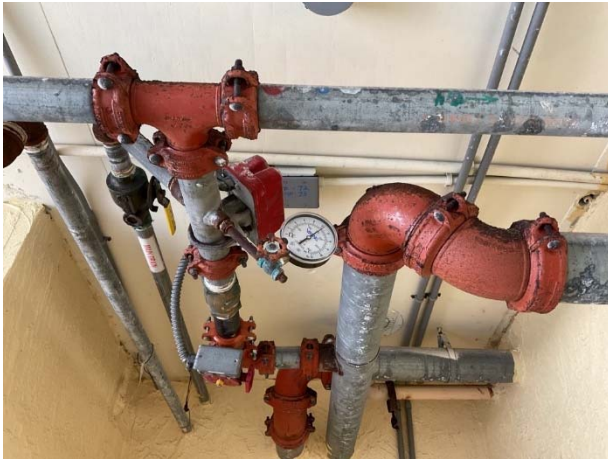
**Rust at pipes**

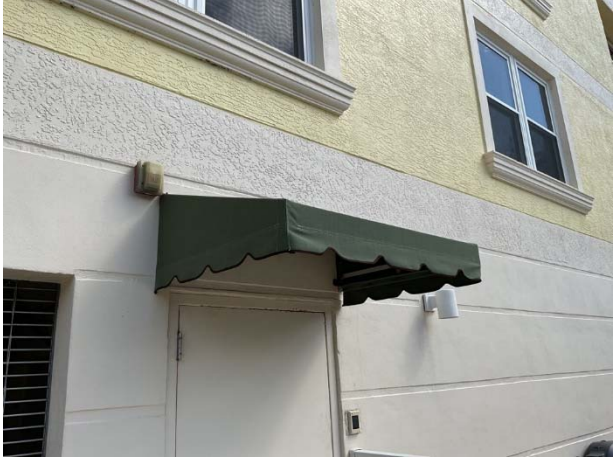
**Condition:** Fair overall with canvas deterioration evident

**Awning**

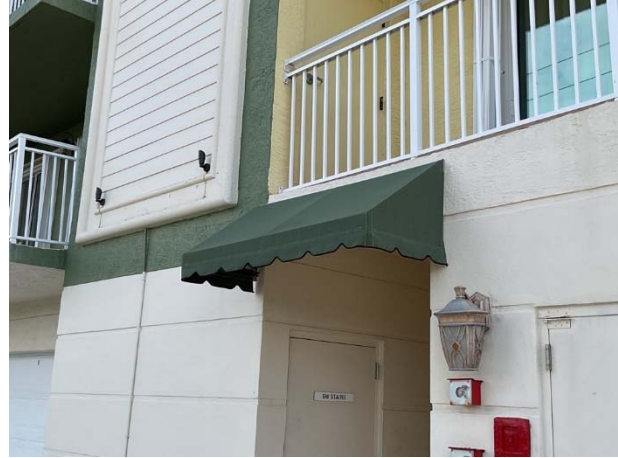
**Awning**

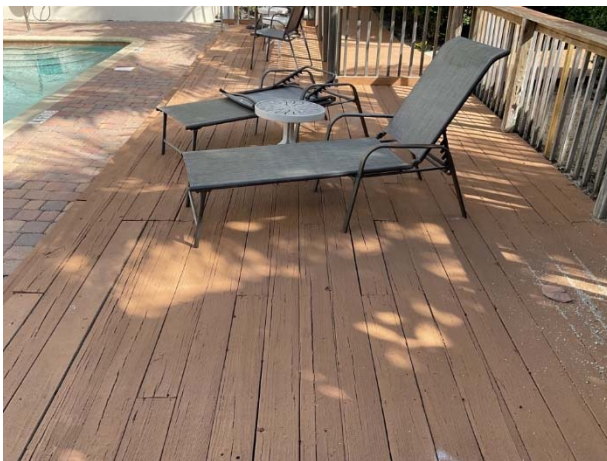
**Condition:** Fair overall with weathered wood and warped components evident

**Deck board deterioration**

- General - Replacement of the wood deck boards at the boardwalk to address the identified deterioration and prevent safety hazards from developing
- General - Refinishing of the pool plaster, tile and coping to improve the appearance and desirability of the community and to address any potential leaks that have developed in the pool structure

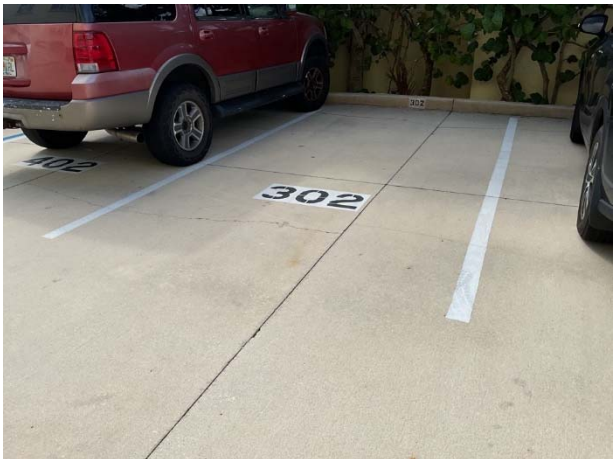
**Condition:** Fair overall with periodic cracks evident.

**Concrete cracks**

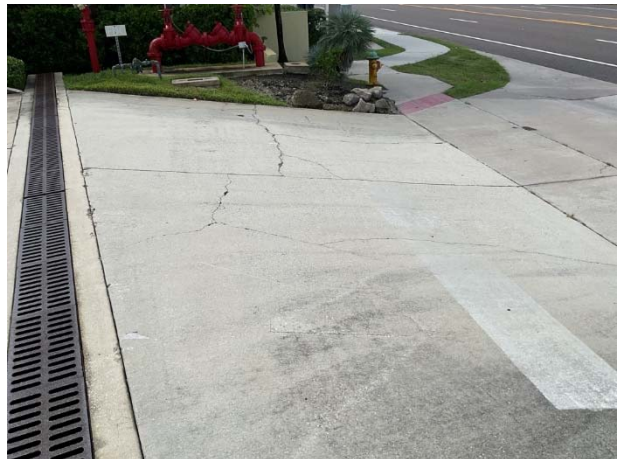
**Concrete cracks**

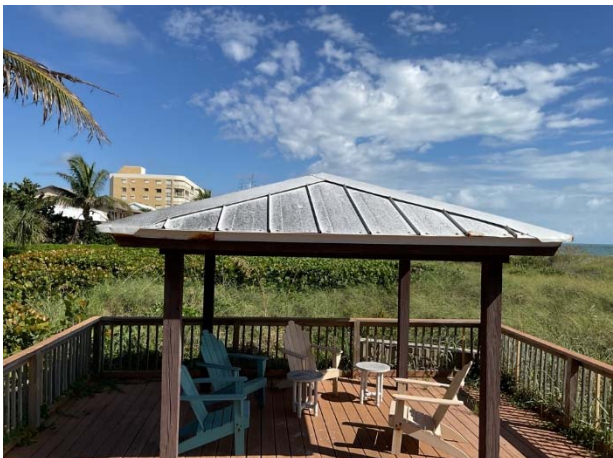
**Condition:** Fair to poor overall

**Metal roof deterioration**

- General - Replacement of the gazebo structure to address accelerated deterioration caused by the structure's proximity to the beach
- General - Partial replacement and repair to the concrete parking area to address cracks and prevent further deterioration

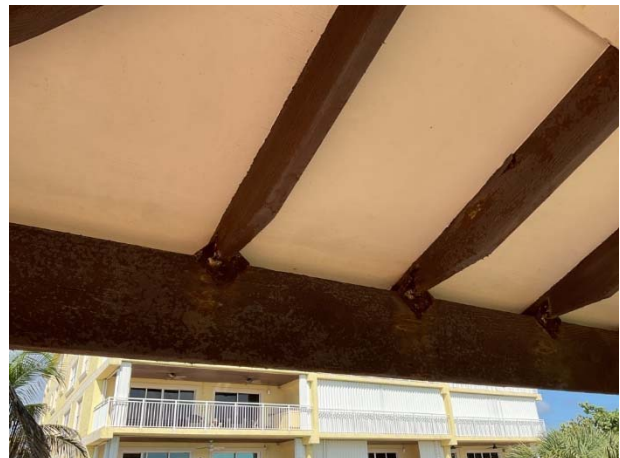
**Fastener rust**

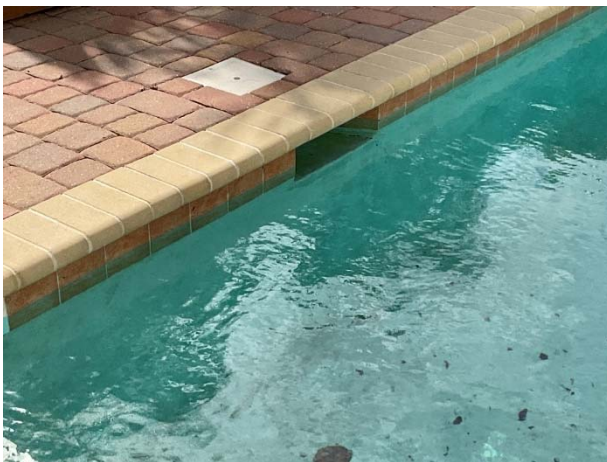
**Condition:** Good to fair overall with isolated cracks and tile damage evident.

Plaster cracks

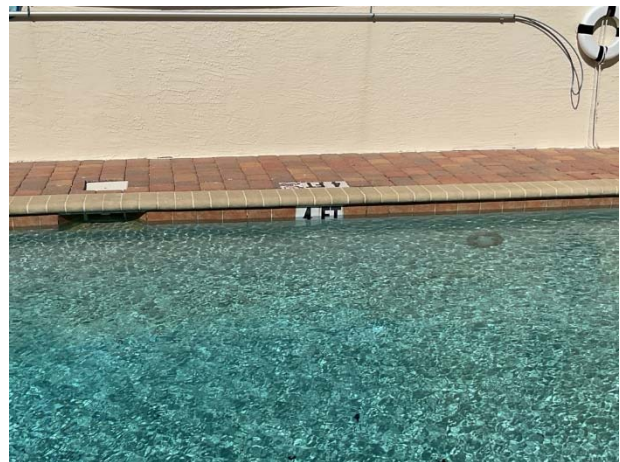
Tile damage
