Ocean Paradise Condominium Association, Inc.  
Cocoa Beach, Florida

At the direction of the Board that recognizes the need for proper reserve planning, we have conducted a *Structural Integrity Reserve Study* of Ocean Paradise Condominium Association, Inc. in Cocoa Beach, Florida and submit our findings in this report. The effective date of this study is the date of our visual, noninvasive inspection, September 20, 2023.

**Reference:** 222895

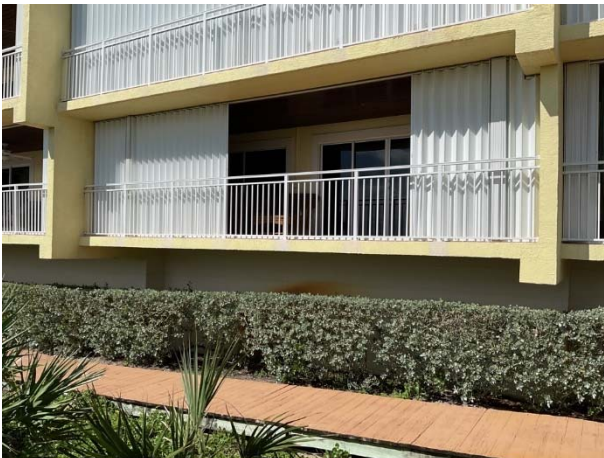
**Efflorescence at railing attachment points**

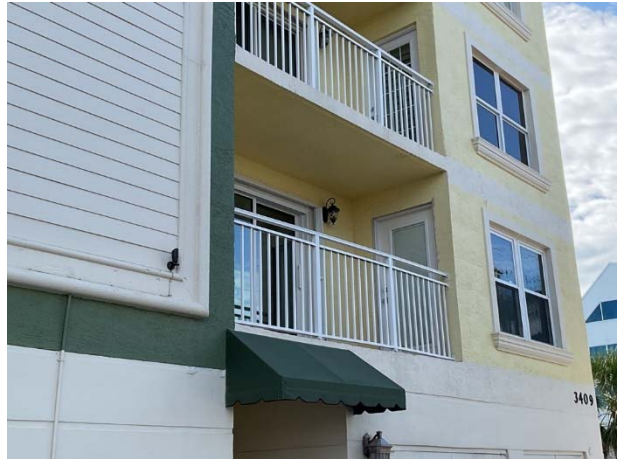
**Bent railing section**

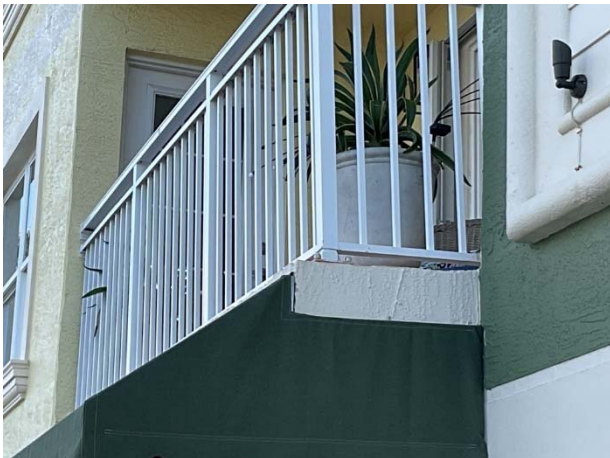
**Mechanically attached railing post**

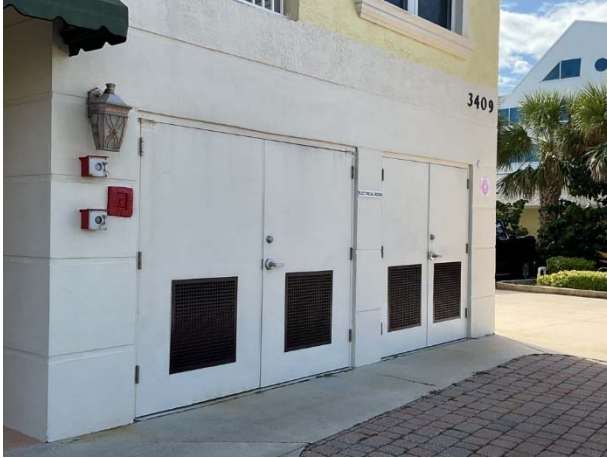
**Utility doors**

**Condition:** Good to fair overall with limited deterioration evident

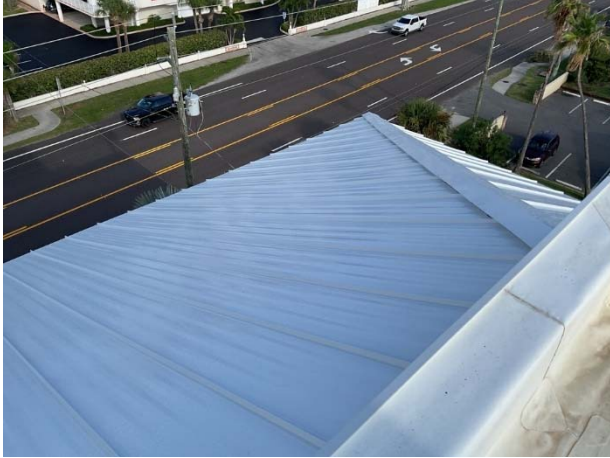
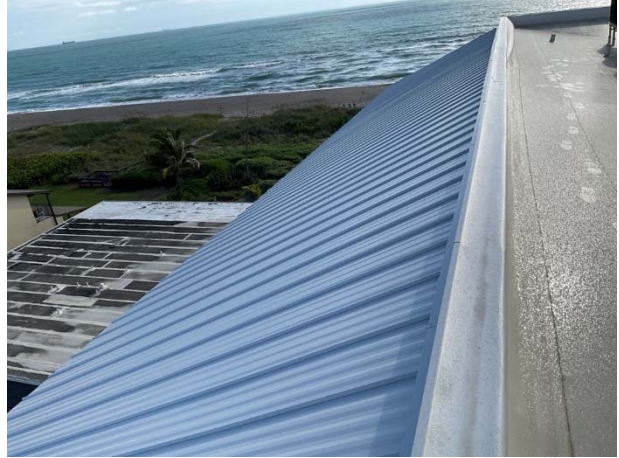
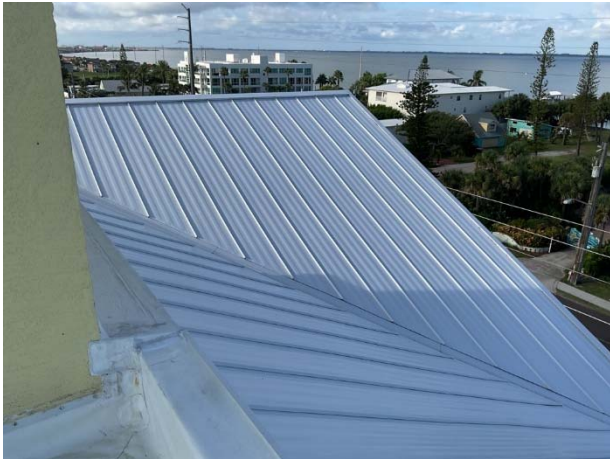
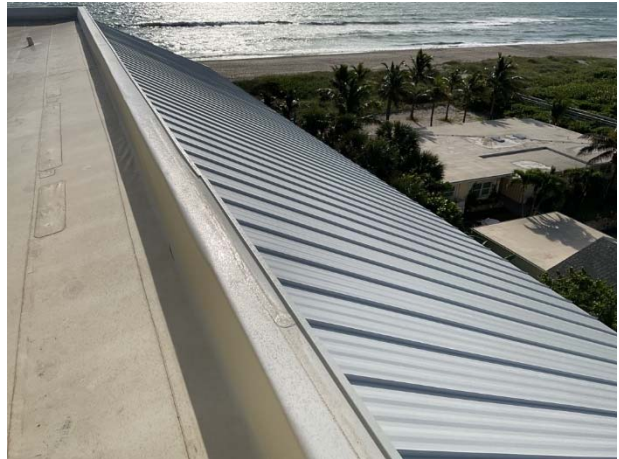
**Metal roof**

**Condition:** Good overall with no significant deterioration evident from our visual inspection from the flat roof and from the ground. Management does not report a history of leaks.

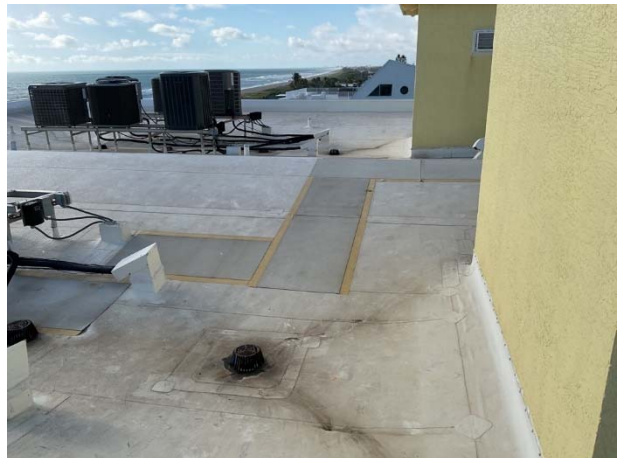
**Patches**

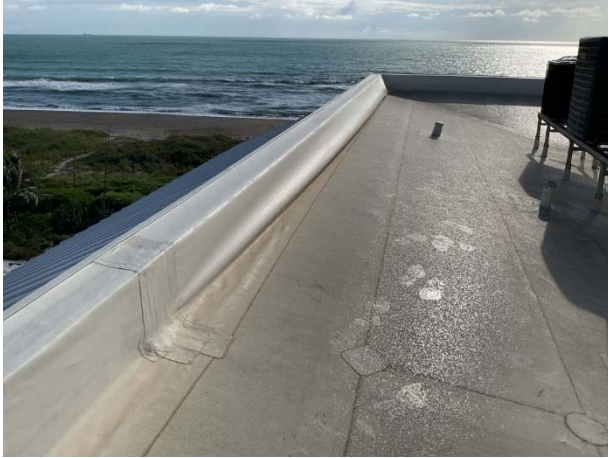
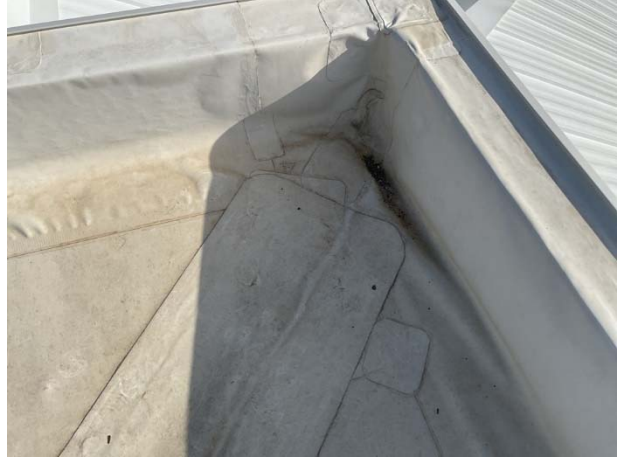
**Bulges in the membrane**

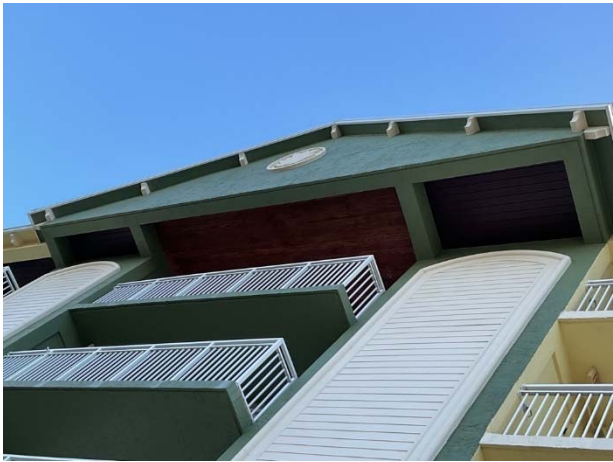
**Wood soffit on building front façade**

**Condition:** The soffits are in good to fair overall condition with no significant deterioration evident from our visual inspection from the ground

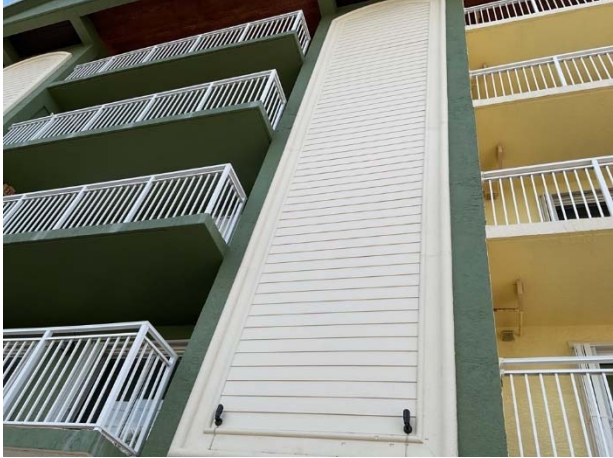
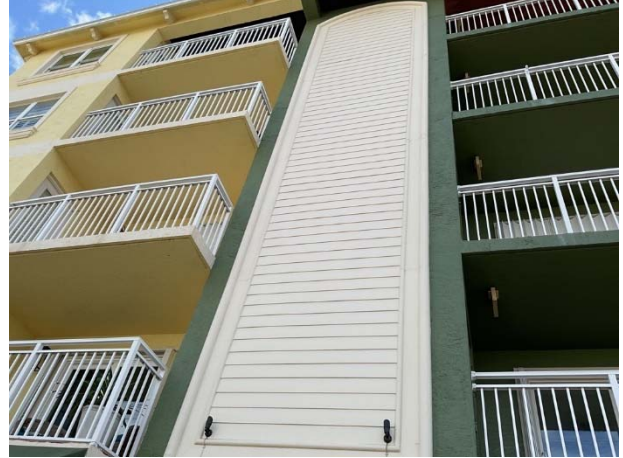
**Fiber cement siding overview**

**Condition:** The accent siding is in good to fair overall condition with no significant deterioration evident.

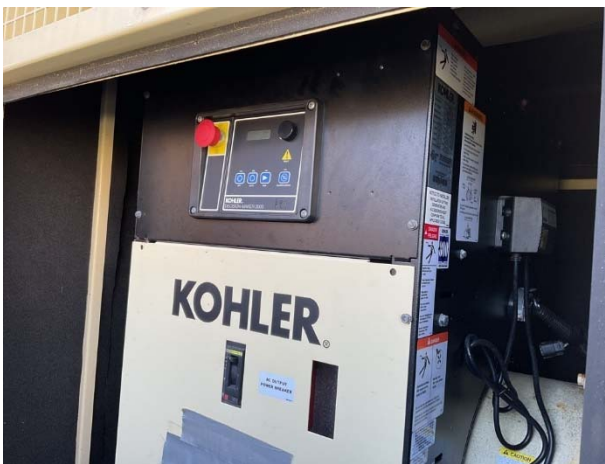
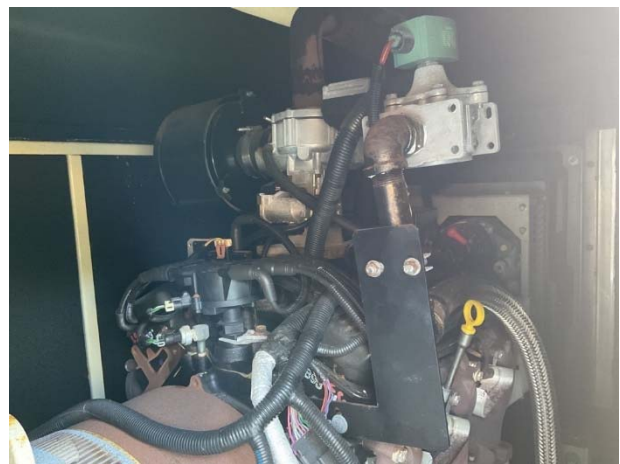
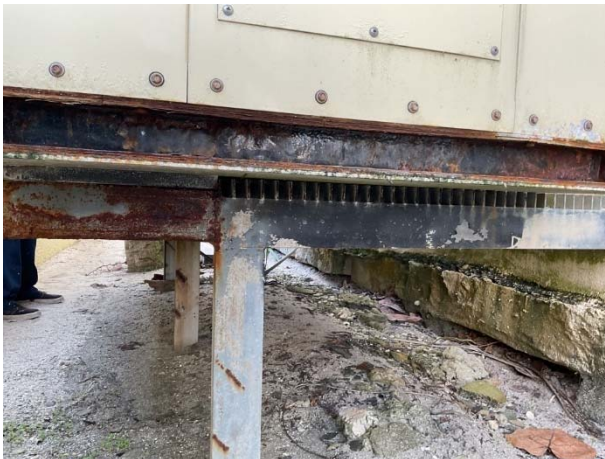
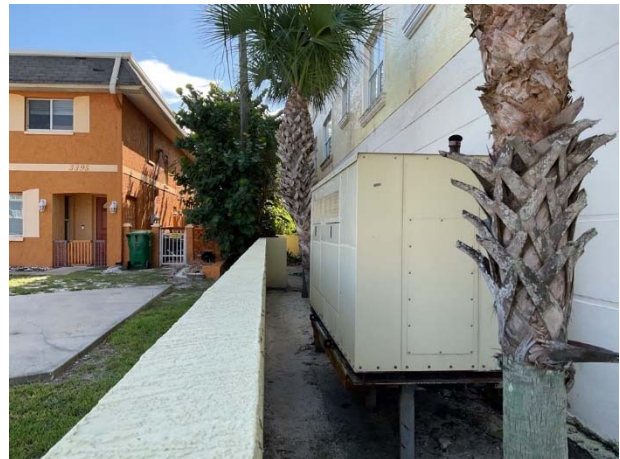
**Condition:** Reported satisfactory without operational deficiencies. Operation of the generator was demonstrated by an Association representative as part of our inspection.

Generator controls

Emergency generator

Generator housing

**Preventative Maintenance Notes:** We recommend the Association obtain and adhere to the manufacturer's recommended maintenance plan. The Association conducts weekly load tests. We also recommend the Association maintain a maintenance contract

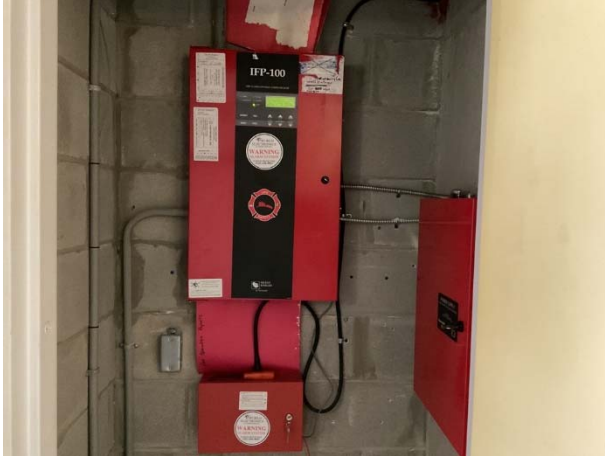
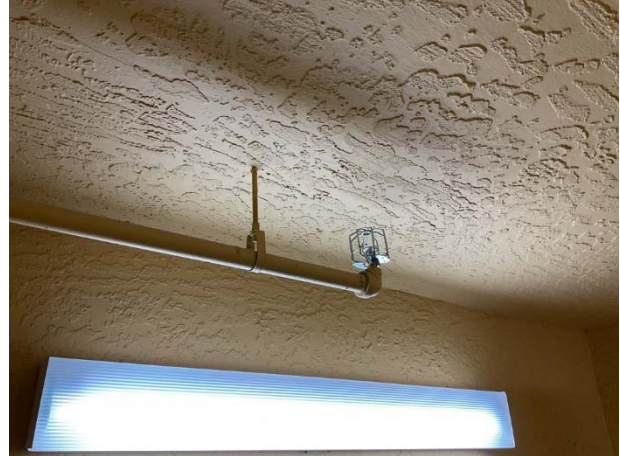
**Conditions:** Reported satisfactory without operational deficiencies. The life safety system was last inspected in November of 2022. The system was tagged green at the time of that inspection.

Control panel

Fire suppression system sprinkler and emergency light fixture

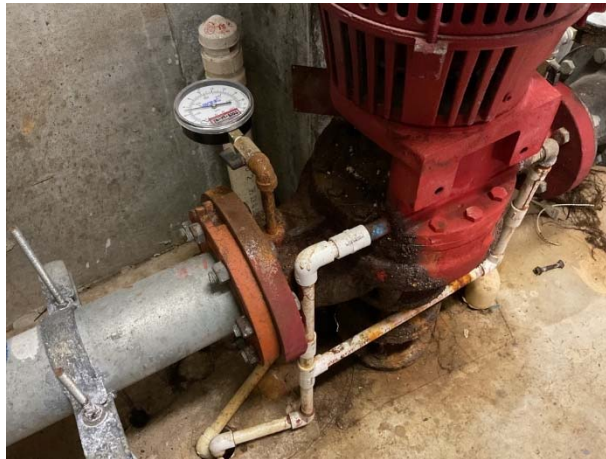
- The fire suppression pump was last inspected in October of 2022
- The fire suppression pump was tagged green at the time of that inspection
- We did not note active leaks at the time of our inspection
- We note evidence of previous leaks due to rust on the plumbing

**Fire suppression pump**

**Component Detail Notes:** Prior to replacement, the Association should schedule periodic inspections to maintain its correct operation in the event of an emergency. Ocean Paradise should also anticipate, as normal maintenance, interim repairs and component replacements to maximize its remaining useful life.

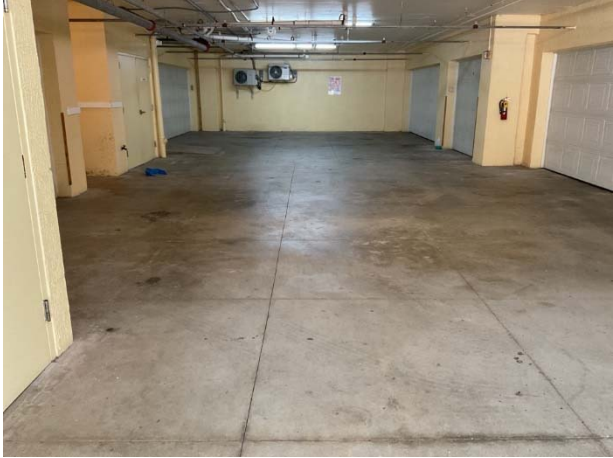
**Condition:** Good to fair overall with cracks evident.

**On-grade garage floor overview**

- Complete inspection of the floor
- Selective cut out and replacement of up to five percent (5%), or 120 square feet, of the on-grade concrete
- Crack repairs as needed

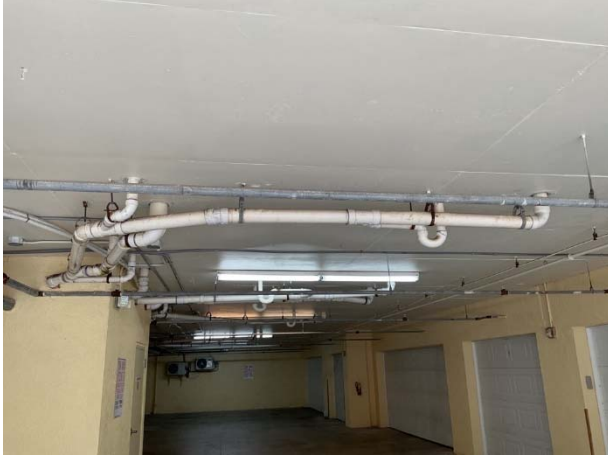
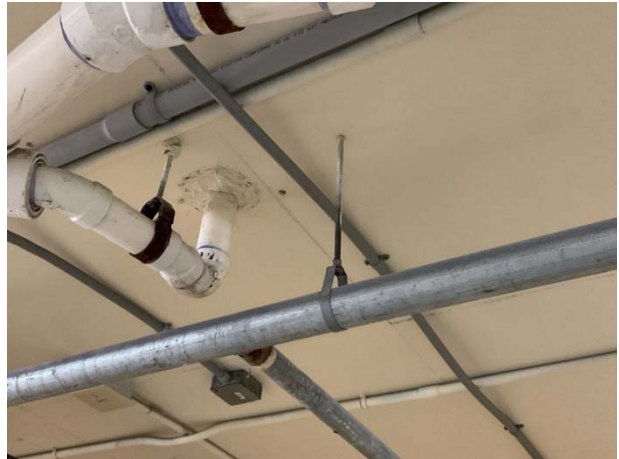
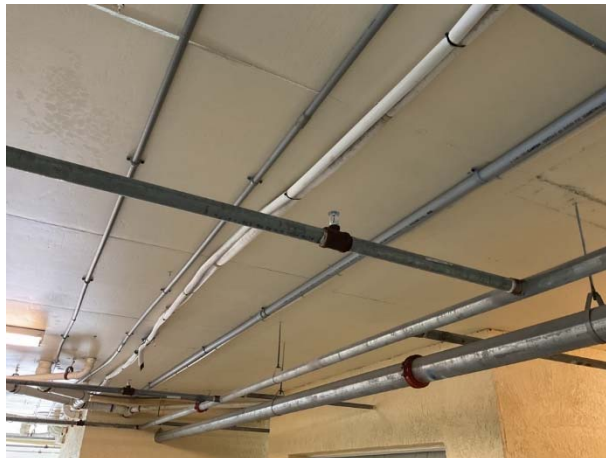
**Condition:** Fair overall with pipe rust and sprinkler head rust evident.

**Fire suppression system**

**Pipe hanger**

**Fire suppression system head**

- Annually:
  - Complete full inspection of valves, hangars, pipes, fittings and heads
  - Ensure sprinkler heads and pipes are free of ornamentations and coverings
  - Check for pipe corrosion and water leakage
  - Conduct paint finish applications to the pipes as needed as these protective finishes may extend the overall useful life in highly corrosive environments

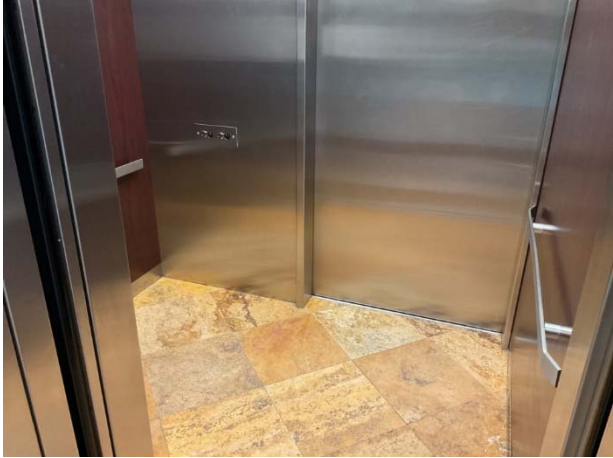
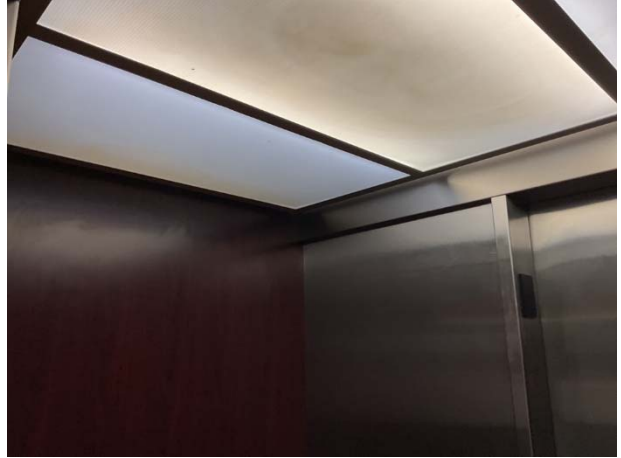
**Condition:** Good to fair overall with no significant deterioration evident.

**Cab floor coverings**

**Cab wall coverings and ceiling lights**

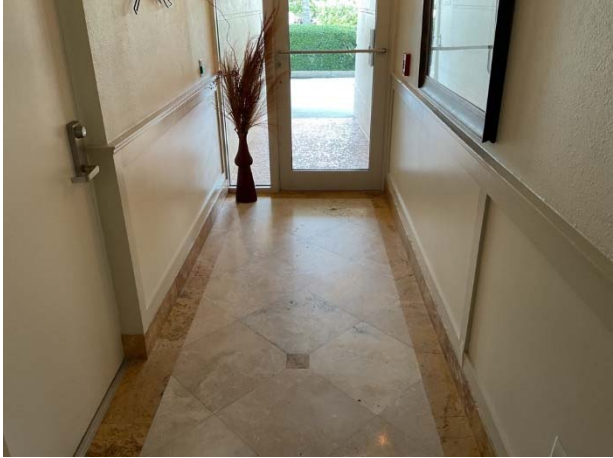
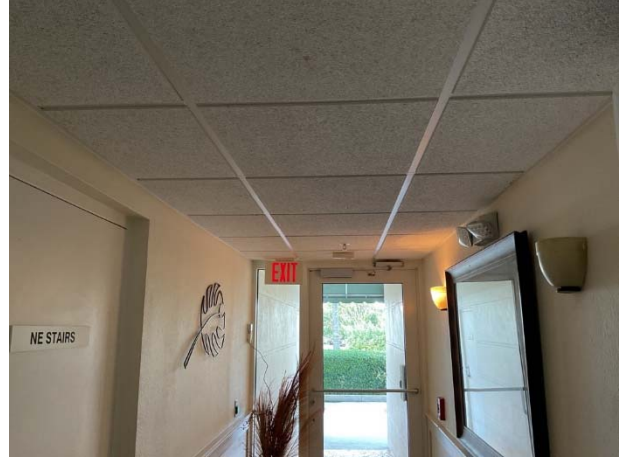
**Condition:** Good to fair overall with no significant deterioration evident.

**Lobby finishes**

**Expenditure Detail Notes:** Expenditure timing and costs are depicted in the **Reserve Expenditures** table in Section 3. We recommend the Association perform interim paint finishes and fund those projects through the operating budget.

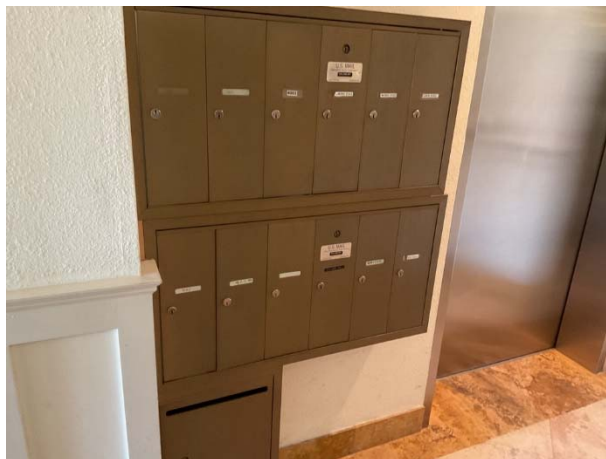
**Condition:** Reported good to fair overall

**Mailboxes**

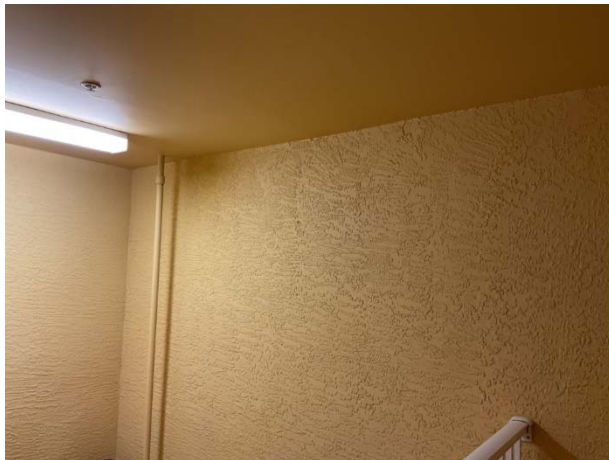
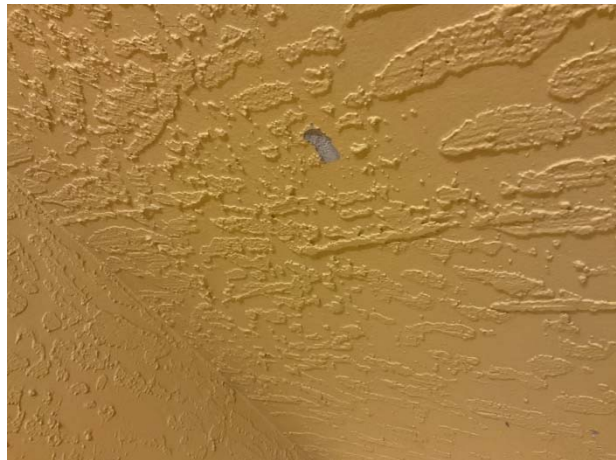
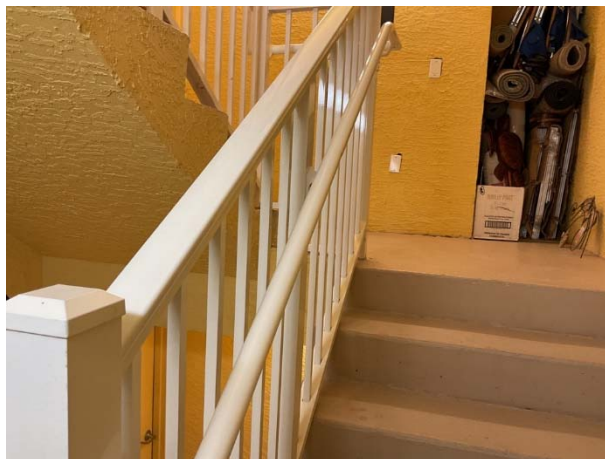
**Conditions:** Good to fair overall with minor scuffs evident.

**Stairwell paint finishes**

**Paint chips**

**Aluminum railing**

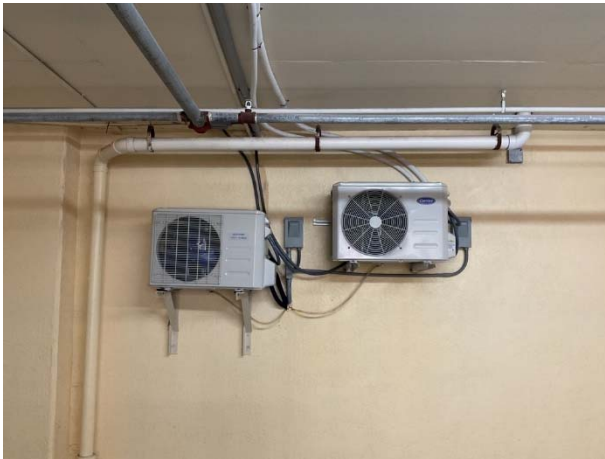
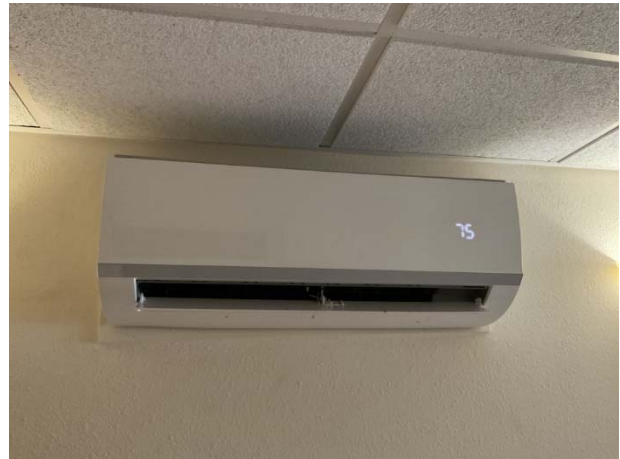
**Condition:** Reported satisfactory without operational deficiencies

Mini-split system condensing units

Mini-split system air handling unit

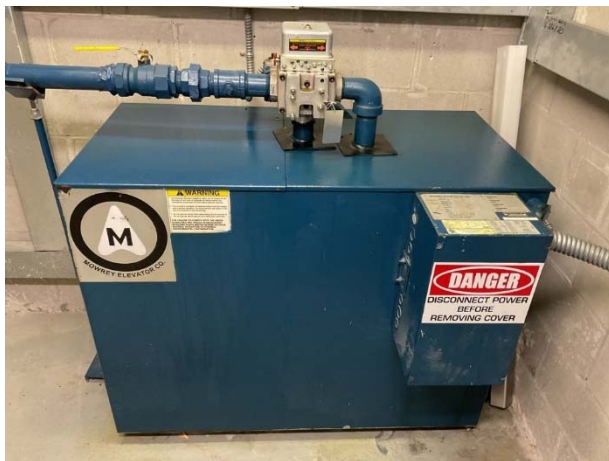
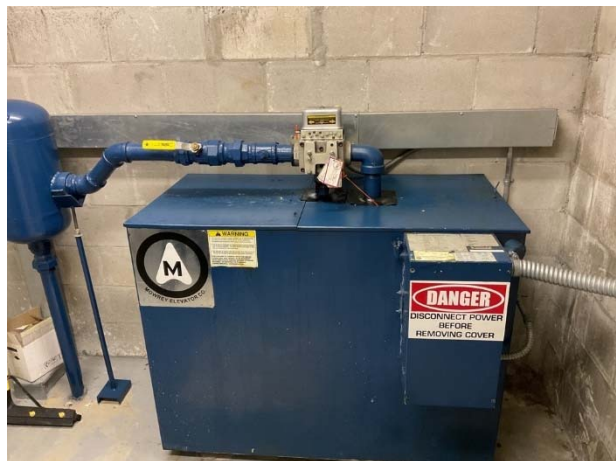
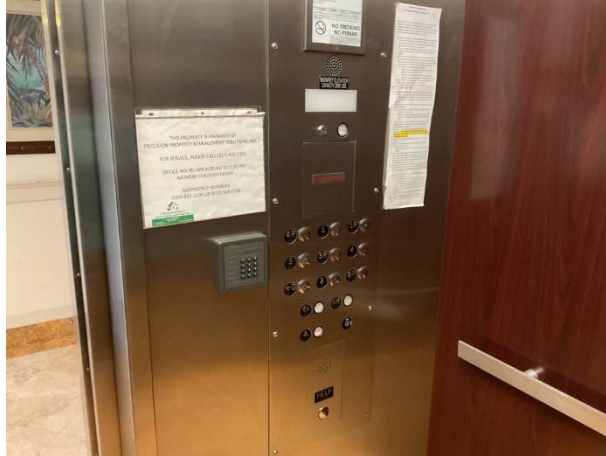
**Condition:** Reported satisfactory and service interruptions are reportedly infrequent

Hydraulic elevator equipment

**Hydraulic elevator controls**

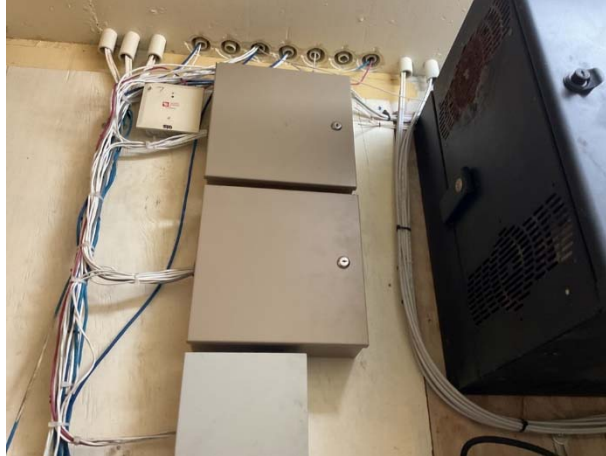
**Condition:** Reported satisfactory without operational deficiencies

**Access control system**

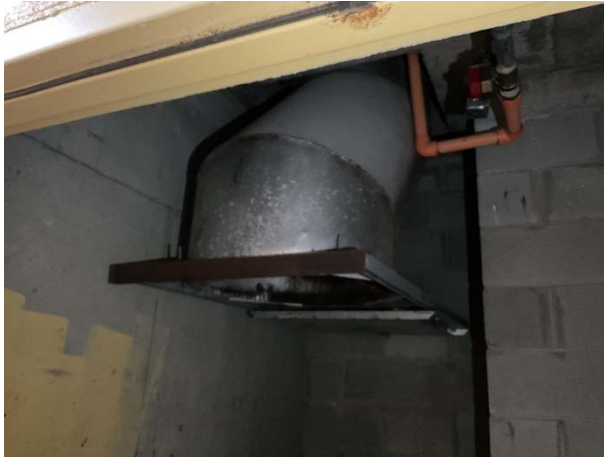
**Condition:** Reported satisfactory without operational deficiencies

**Trash chute**

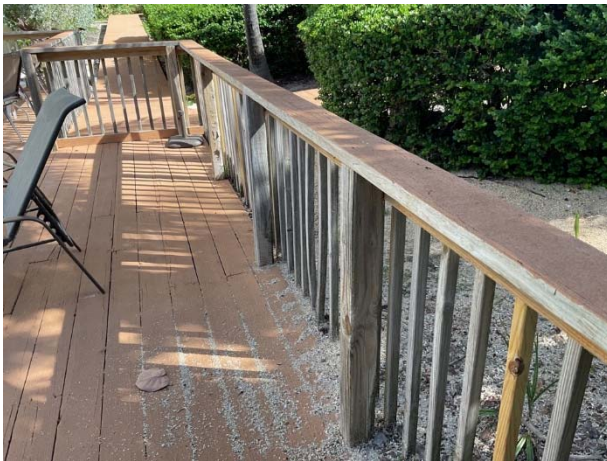
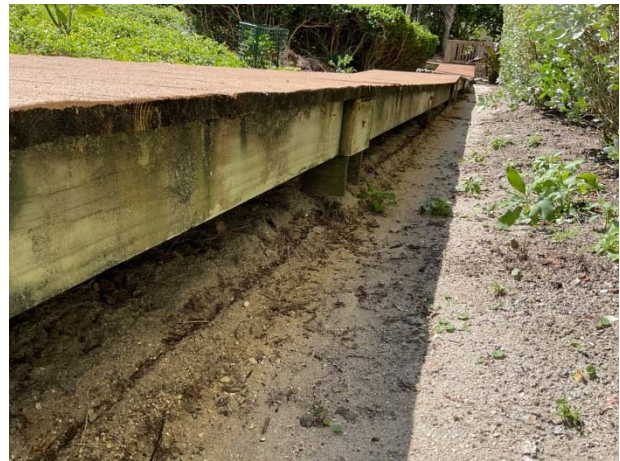
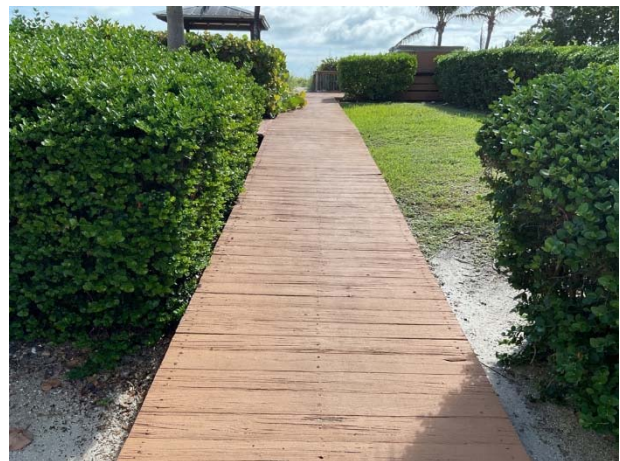
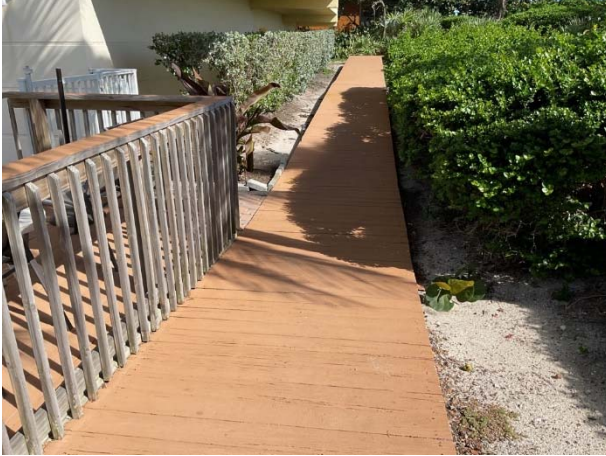
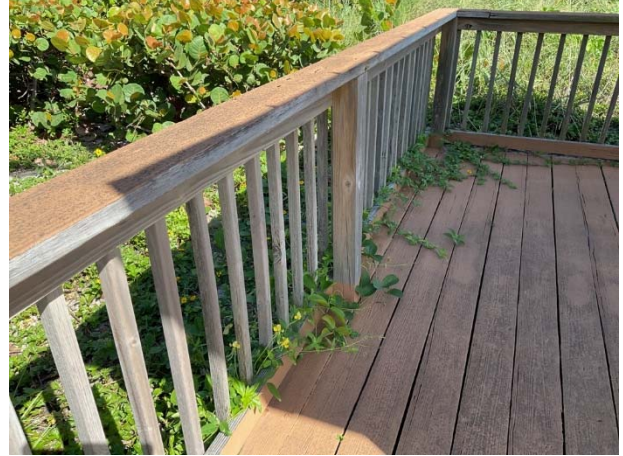
**Condition:** Fair overall with weathered wood and warped components evident

**Boardwalk railing**

**Boardwalk structure**

**Wood boardwalk**

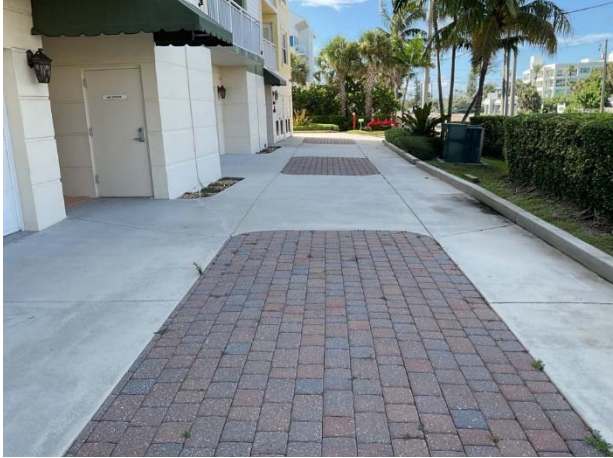
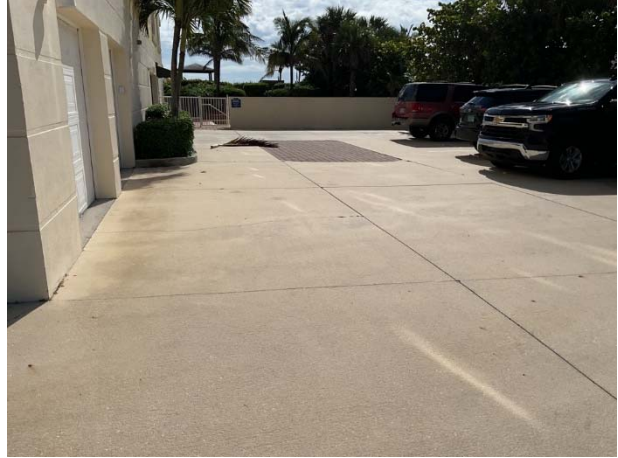
**Condition:** Fair overall with periodic cracks evident.

**Concrete access drive with paver accents**

**Concrete parking area**

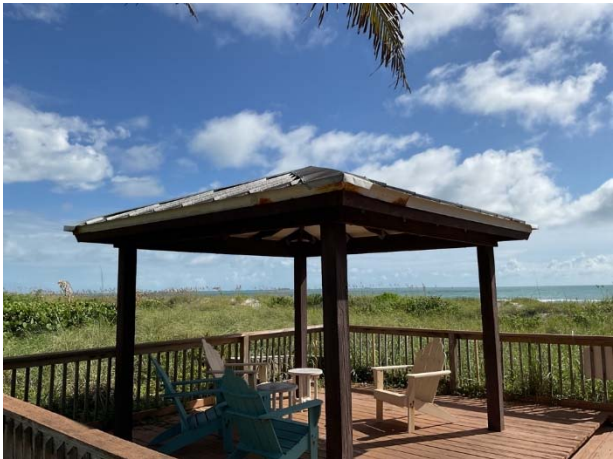
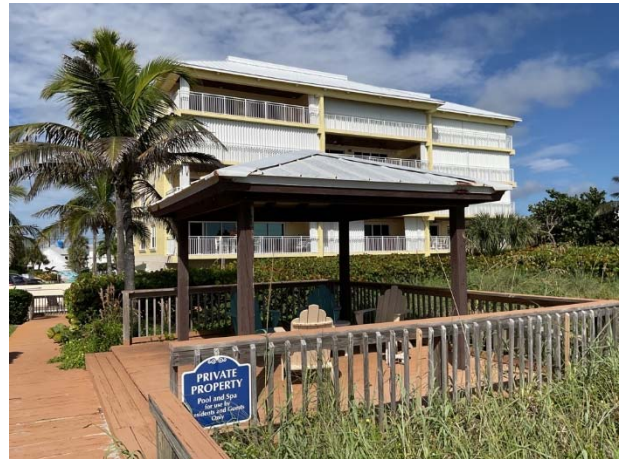
**Condition:** Fair to poor overall

**Gazebo**

**History:** The age of the gazebo was unavailable at the time of our inspection. The Association plans to replace the structure in the near-term.

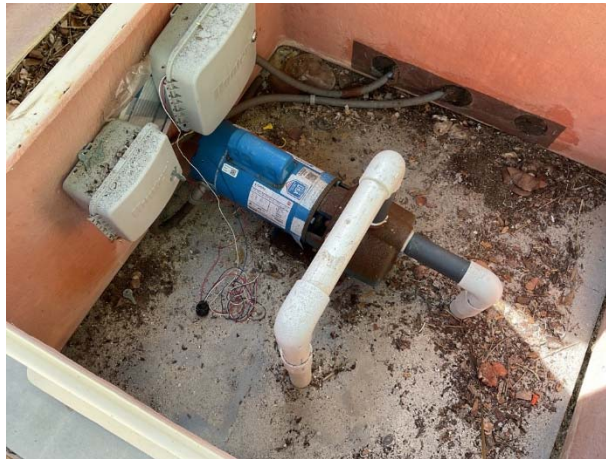
**Condition:** Reported satisfactory without operational deficiencies

**Irrigation pump**

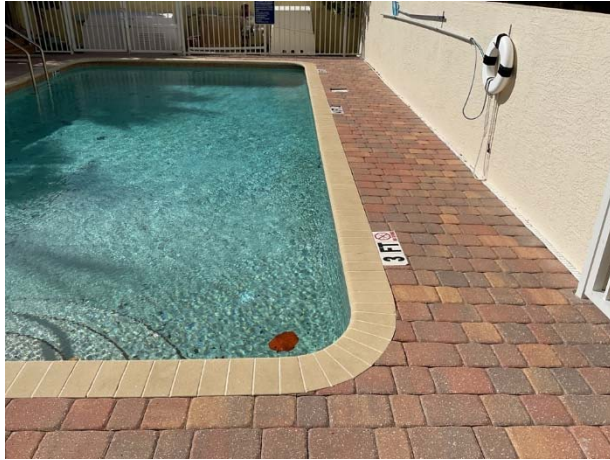
**Condition:** Good to fair overall with isolated settlement evident.

**Paver pool deck overview**

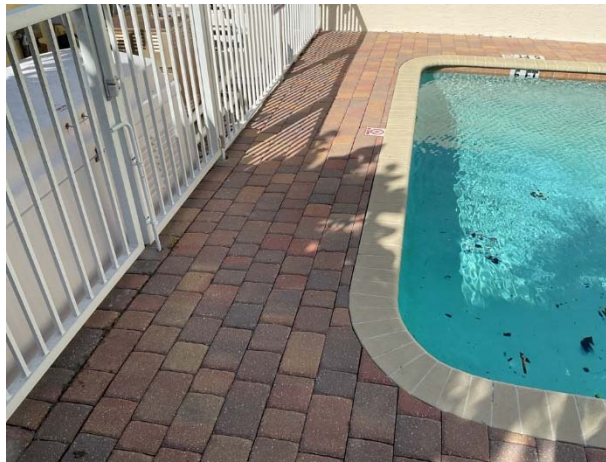
**Paver pool deck overview**

**Paver settlement**

- Annually:
  - Inspect and repair settlement, trip hazards and significant paver spall
  - Reset and/or reseal damaged pavers as necessary
  - Periodically clean and remove overgrown vegetation as needed

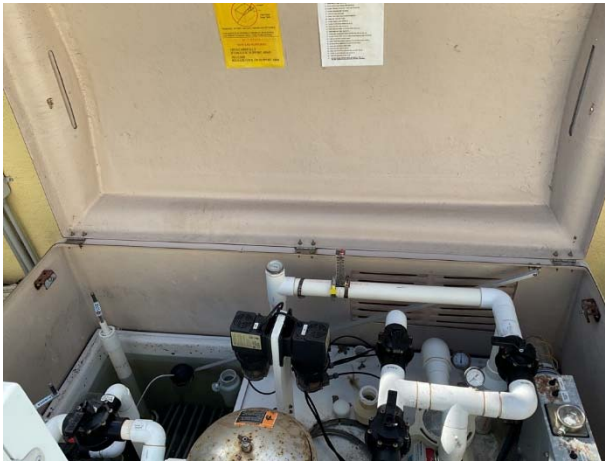
**Condition:** Reported satisfactory without operational deficiencies. We note rust and damage at the heater.

**Pool mechanical equipment**

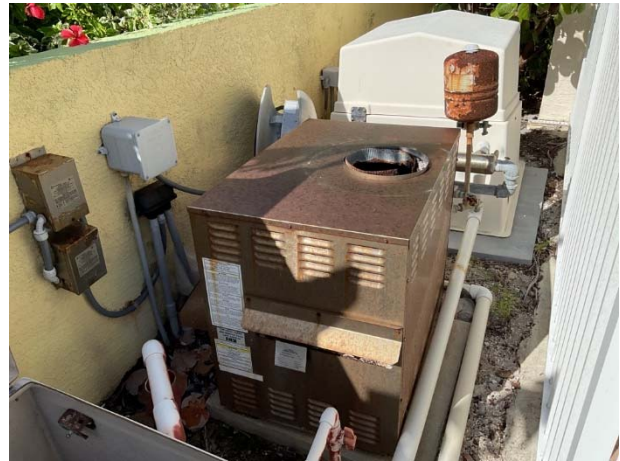
**Pool heater**

**Preventative Maintenance Notes:** We recommend the Association maintain a maintenance contract with a qualified professional and follow the manufacturer's specific recommended maintenance and local, state and/or federal inspection guidelines.

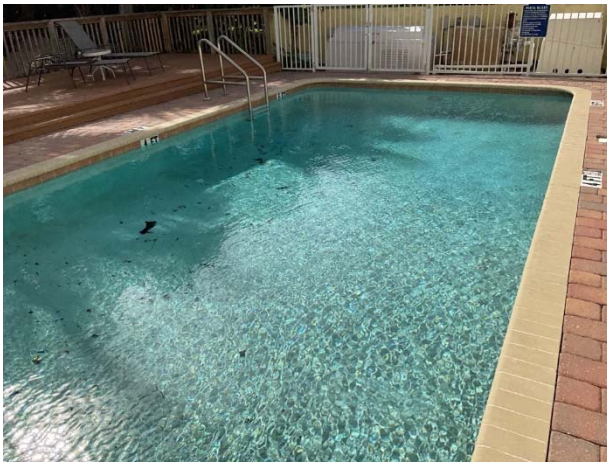
**Condition:** Good to fair overall with isolated cracks and tile damage evident.

Pool plaster finish with tile perimeter

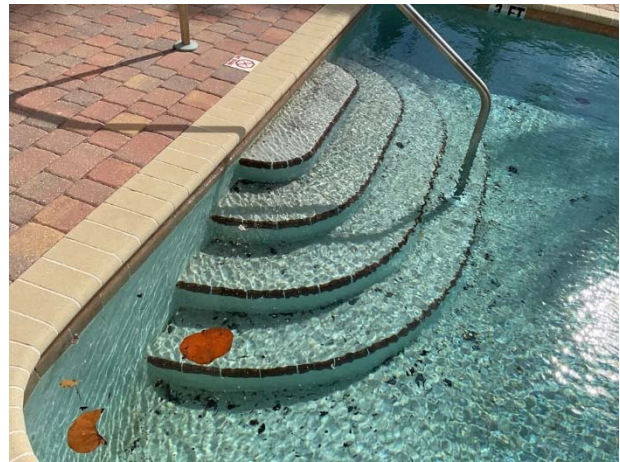
Pool plaster finish with tile perimeter

- Removal and replacement of the plaster finishes
- Partial replacements of the scuppers and coping as needed
- Replacement of tiles as needed
- Replacement of joint sealants as needed
- Concrete structure repairs as needed
